KARST FAILURES IN THE NORTHERN CASPIAN

***Annotation.** There are small scattered karst areas in the Northern Caspian. They are associated with the outcrops of ancient Late Paleozoic rocks, usually represented by strongly dislocated Lower Permian gypsum in the cores of salt domes. In the article, the author gives a brief overview of karst sinkholes located within the boundaries of these karst areas, based on the analysis of various researchers' work and his own field data. These areas are mainly affected by suffosion-karst and gravity-karst faults. The author not only describes the failures themselves, but also indicates the causes of the failures. The oldest karst sinkhole, which has been monitored for many years, is about 100 years old. Karst sinkholes pose a danger when developing karst areas, so their economic and tourist-recreational development without taking into account the impact of karst is unacceptable.*

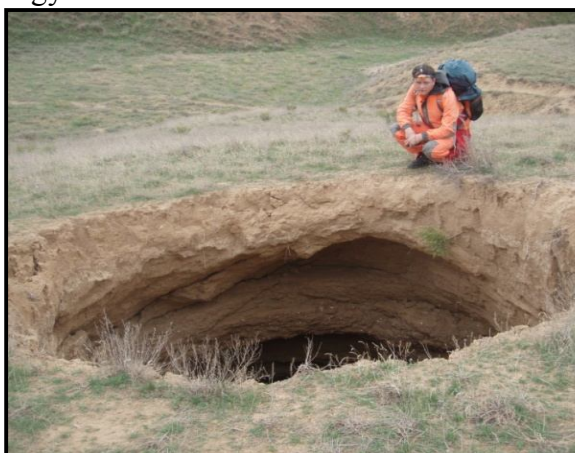
Figure 1 - Suffosion and karst failure in Sharovskaya gully (photo by I.V. Golovachev)

Suffosion failures with karst provocation are present in the vicinity of lakes Baskunchak and Inder. In the Pribaskunchak district, such sinkholes are characteristic of the Sharovskaya gully, the bed of the Gorkaya River and other areas with a large thickness of loose deposits on top of karstic gypsum rocks [4]. A typical ground dip discovered in May 2001 is an example. It was probably formed in 2000 and is located on the southern exposure slope of Sharovskaya gully (Fig. 1). The maximum depth of the failure is up to 4.0 m. The diameter of the throat is about 3.0 m. At a depth of approximately 2.0 m, the failure expands meridionally to 5.0 m in length. The extension boundary falls on a change in the composition of the host sediments. Dense light loamy sandy loam is replaced by looser lumpy dark brown loam with the inclusion of Hvalynian shells. Below the

neck at the bottom there is a rockfall cone about 0.5 m high. The karst gypsum is not exposed in the walls of the sinkhole, but lies lower and is exposed at the bottom of the gully.

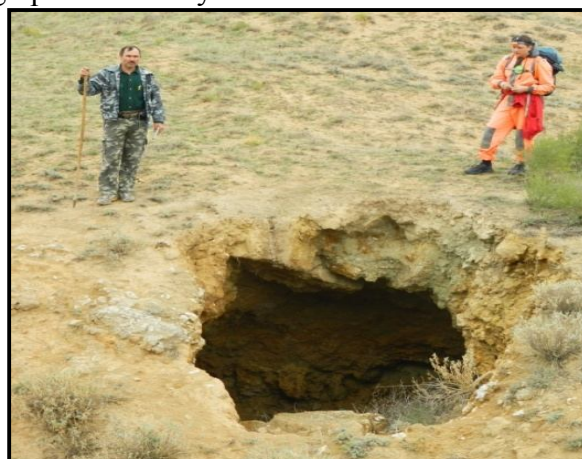
Figure 2 - Corrosion and gravity failure in Sharovskaya gully (Photo by A.S. Sergeev)

In the same gully, a corrosion and gravity failure can also be observed, formed around 1993-1994, in gypsum rocks due to the collapse of the stone vault of a small karst chamber (Figure 2). The underground cavity is approximately 6.0 m in diameter and 2.5-3.0 m high. The entrance throat, located on the periphery of the cavity vault, is about 2.5 m in diameter. The cavity was discovered in May 1995 during expeditionary works by members of the section of speleology and karstology of the Astrakhan Branch of the Russian Geographical Society.

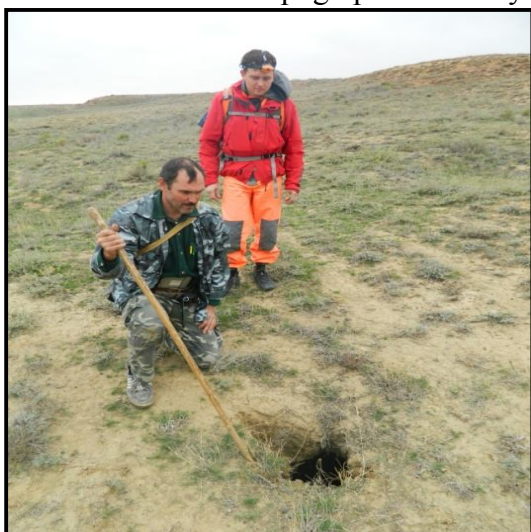
Figure 3 - Hole in the ground (Photo by A.S. Sergeev)

As a rule, the sinkholes are only inspected after they have been formed and opened due to the collapse of the roof. However, in the autumn of 2011, north of the Sharovskaya gully, during expeditionary work, Astrakhan speleologists discovered a 0.25 m diameter hole on the ground surface, behind which a bottle-shaped extension up to 4.0 m in diameter was visible (Fig. 3). The neck of the pit was enlarged with a shovel to a diameter of 0.9 m and then the inner part of the pit was examined (Fig. 4). The maximum depth of the pit was 2.1 m. The vertical walls of the trench inside were composed of interbedded brown clay 15-20 cm thick and yellow thin sandy interlayers up to 5 cm thick (Fig. 5). No karst rocks were exposed. Thus, it was possible to inspect the underground suffosion-karst cavity that had formed before the natural collapse of the roof, to measure it and to make a topographical survey (Fig. 6).

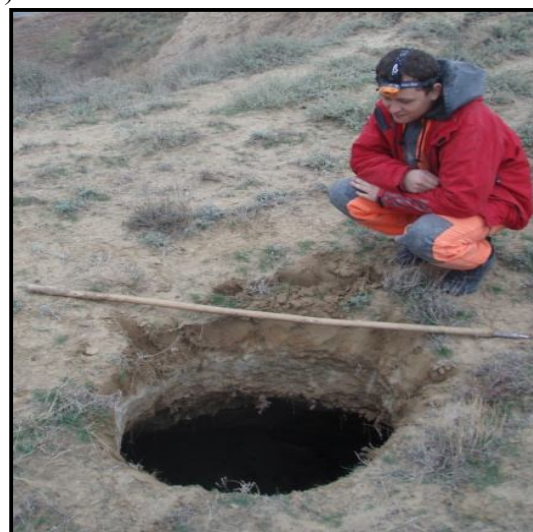
Figure 4 - Enlarged neck (photo by I.V. Golovachev).

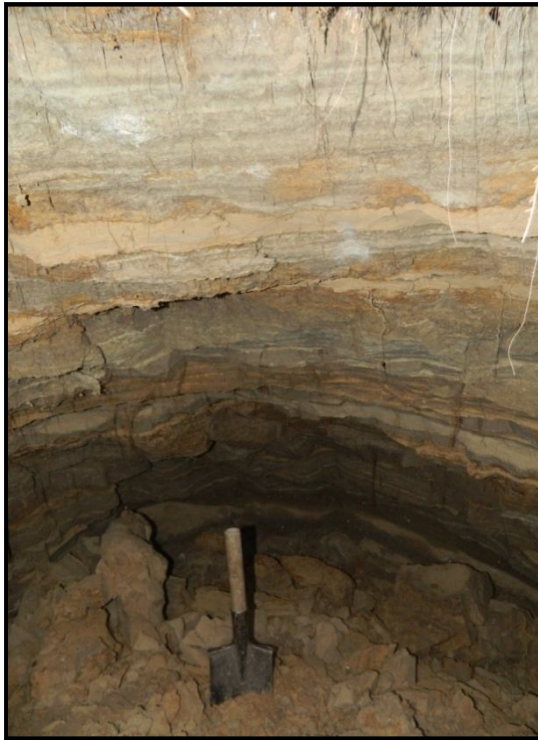
Figure 5 - View inside the gap
(Photo by A.S. Sergeev)

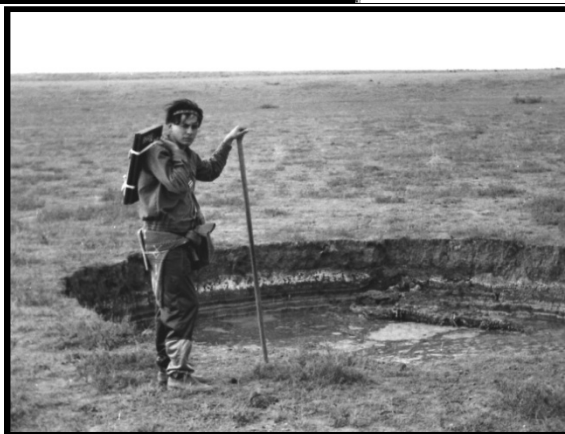
Figure 8 - Failure at Gorky Lake in 1994.
(Photo by I.V. Golovachev)

In October 1994, during the expedition work, a fresh karst sinkhole was discovered one hundred meters to the northeast of Gorkoe Lake, northeast of the bowl of Lake Baskunchak (Fig. 8). The sinkhole had a latitudinal direction and dimensions of 6.0 by 4.0 m. The depth of the failure was about 3,5-4,0 m. There was water at a depth of 0.6-0.7 m from the top edge of the trough with foam floating on the surface. Along the perimeter of the trench, parallel to the edge, cracks of subsidence had already formed. Loose laminated loamy and sandy loam layers were exposed in the walls of the cavity.

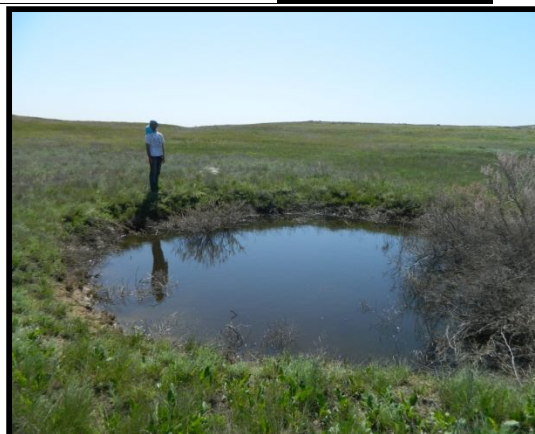
Figure 9 - Failure at Gorky Lake in 2012.
(Photo by I.V. Golovachev)

Between 1994 and 2012 (i.e. over 13 years!), the ditch has widened and shallowed. The edge of the pit has flattened and flattened out (Figure 9). Its depth has become less than one metre.

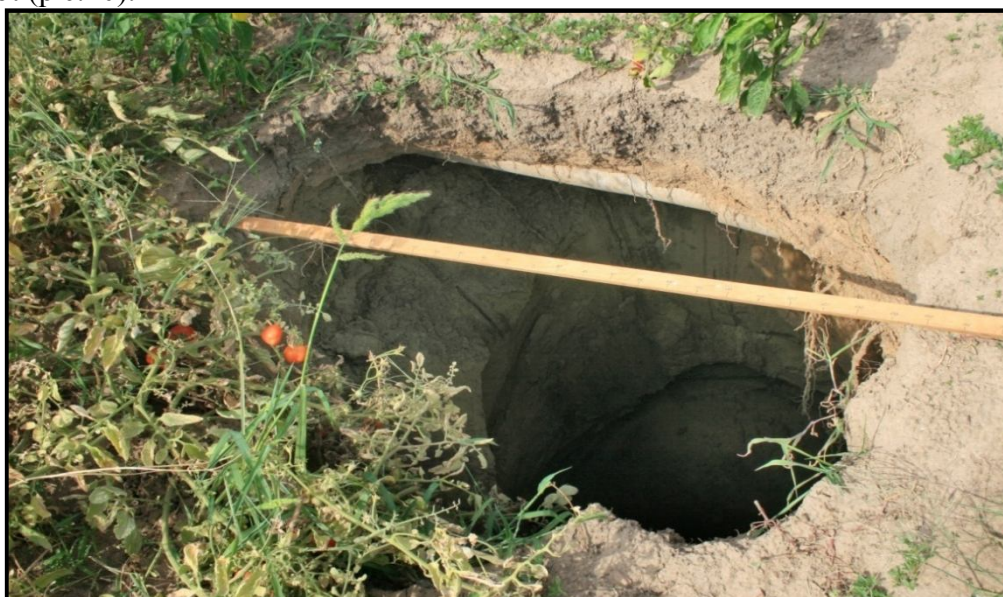
Figure 10 - Failure in the village of Nizhny Baskunchak (Photo by O.M. Vyazmin)

Karst sinkholes are also formed in populated areas. So, for example, on 10.08.2007 at 21.00 in Nizhnij Baskunchak village, Gorkogo street, 14, a suffusion-karst cavity was formed on the household plot (pic.10).

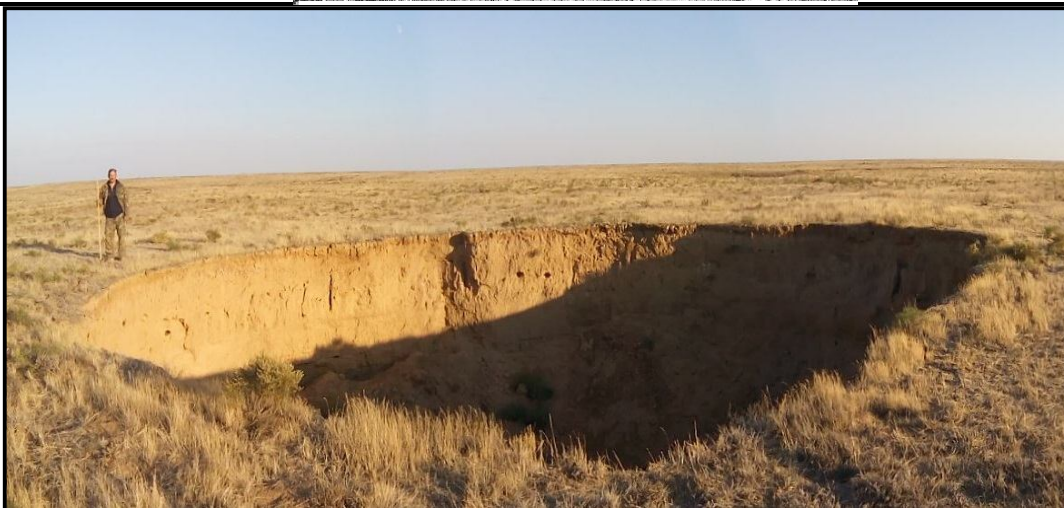
Figure 11 - Karst sinkhole in the Turgai koshar (photo by E.A. Lisitsa)

The last large karst sinkhole was formed in 2008 in the northern karst field in the vicinity of the Koshara Turgai shepherd's field (Figure 11).

The sinkhole was discovered in time. It was found and examined by members of the karst caving section of the Astrakhan branch of the RGS on 03.10.2014 during the expedition work on the northern gypsum field. The time of formation of the pit was reported by a shepherd from the point "Koshara Turgai".

The sink-hole at the time of the survey was slightly oval in shape, extending in a meridional direction. Its size was about 15.5 x 17.5 m, with a depth of up to 6.0 m. The trench is embedded in horizontally bedded loose sandy-loam sediments. The walls of the pit are vertical, the bottom is flat and dry. Karst rocks are not exposed. The failure occurred suddenly and without prior ground subsidence. At the time of examination, cracks were formed along the perimeter of the failure at the distance of 0.4-1.0 m from the edge of the failure throat. The failure remained unfilled and its development can be monitored in the future.

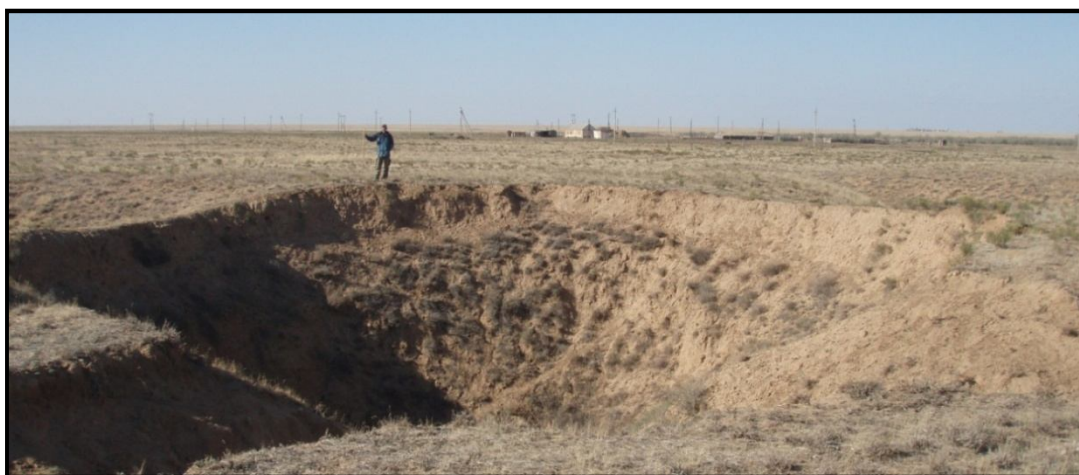
Figure 12 - An old pit near the Turgai sheep barn (Photo by M.A. Sokolov)

Subsequently, the sinkholes become conical and protruding due to the collapse of the walls (Fig. 12). They are characterised by regular rounded shapes without erosion incisions and are generally symmetrical.

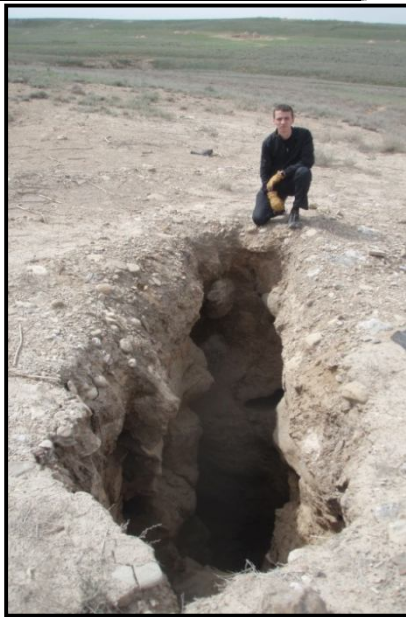
Figure 13 - Karst sinkhole
(Photo by I.V. Golovachev)

There are also karst sinkholes in the vicinity of Lake Inder. One of the sinkholes examined by Astrakhan speleologists (Fig. 13) is located on the side of an old asphalt road [6, p. 55]. Its opening is most likely due to the vibration of soils caused by the frequent movement of heavy quarry equipment along the road. The failure is of the corrosion-soil (or corrosion-gravity) type.

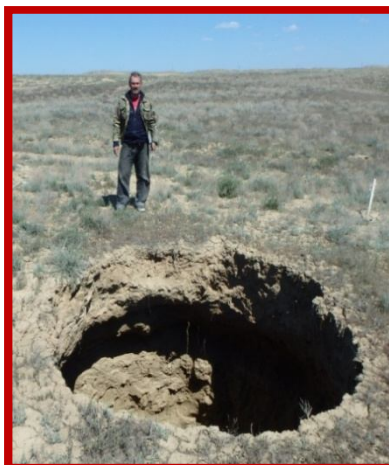
Figure 15 - Fresh failure
(Photo by M.A. Kuznetsova)

In May 2017, speleologists from Astrakhan discovered a rather fresh suffosion-karst sinkhole (Fig. 15) [6, p. 56].

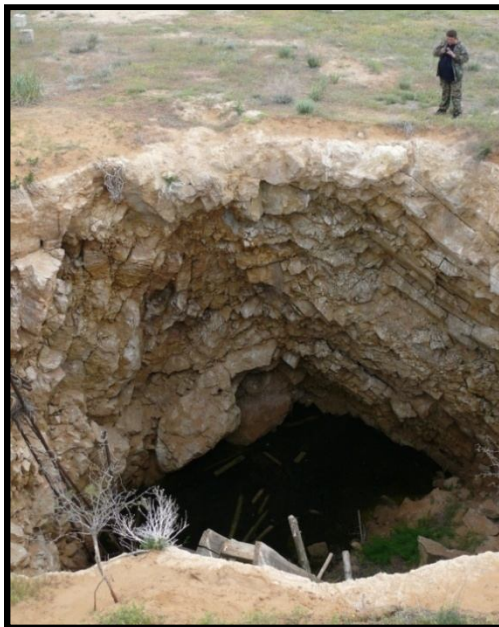
Figure 21 - Faulty well
(Photo by A.A. Shaposhnikov)

As a result of the study of this sinkhole, the dynamics of changes in the size of the sinkhole was revealed. In 1934, the size of the throat of the sinkhole was 4.90 m × 6.50 m, and 85 years later in 2019, it had already reached 10.0 m × 11.0 m. Thus, the neck has almost doubled in size! It is also interesting that over such a long period, the walls of the cavity have not aligned, but have remained vertical (Fig. 21).
